LINER DIAMETER MEASUREMENT SERVICE REPORT

General Data

Vessel:	-
Owner/manager:	-
Flag:	-
Engine type:	6S60MC-C
IMO:	-
Running hours:	50380
Built:	2010
Device used:	LDM Generation 4
Stroke:	2292

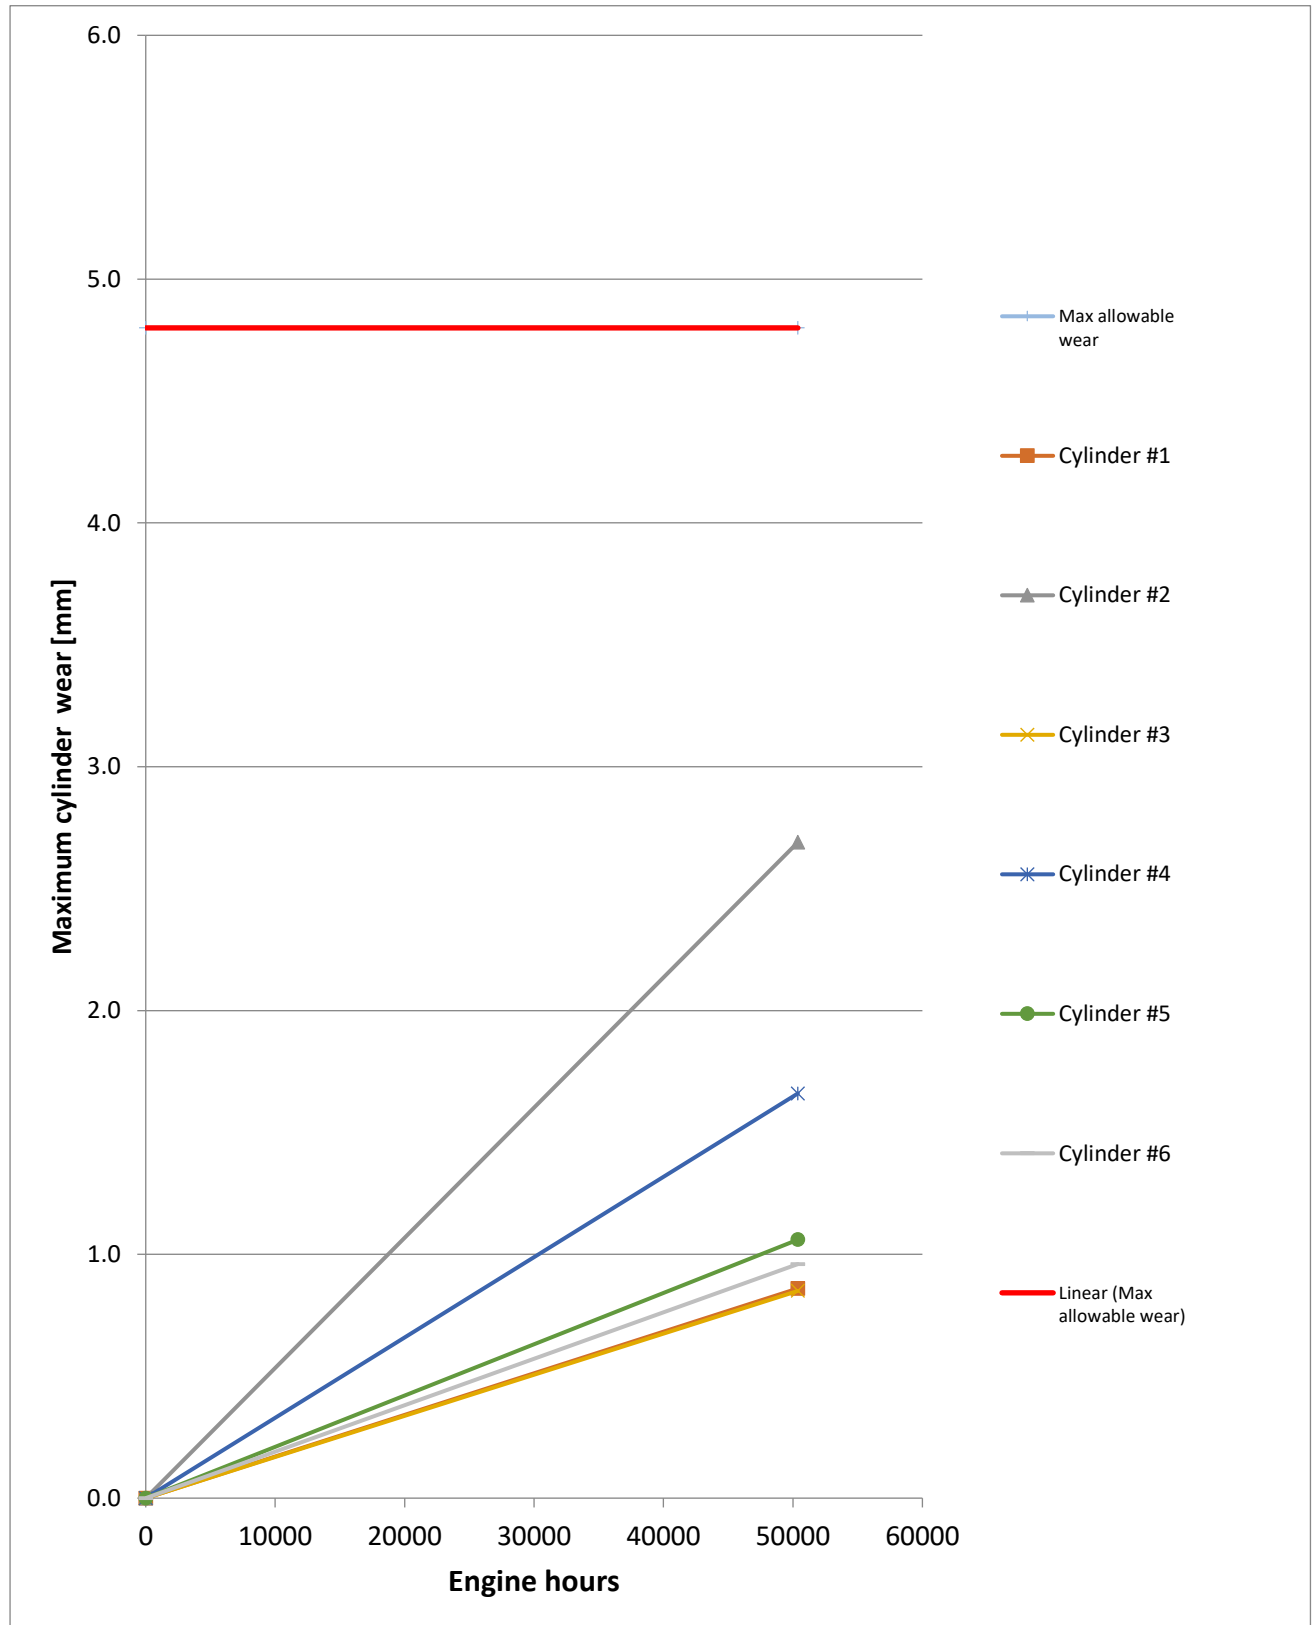
The cylinder wear was found to be between 0.85 mm and 2.69mm with an average of 1.347 mm corresponding to an average specific wear rate of 0.027 mm/1000h.

The Graph below shows the current wear for all units

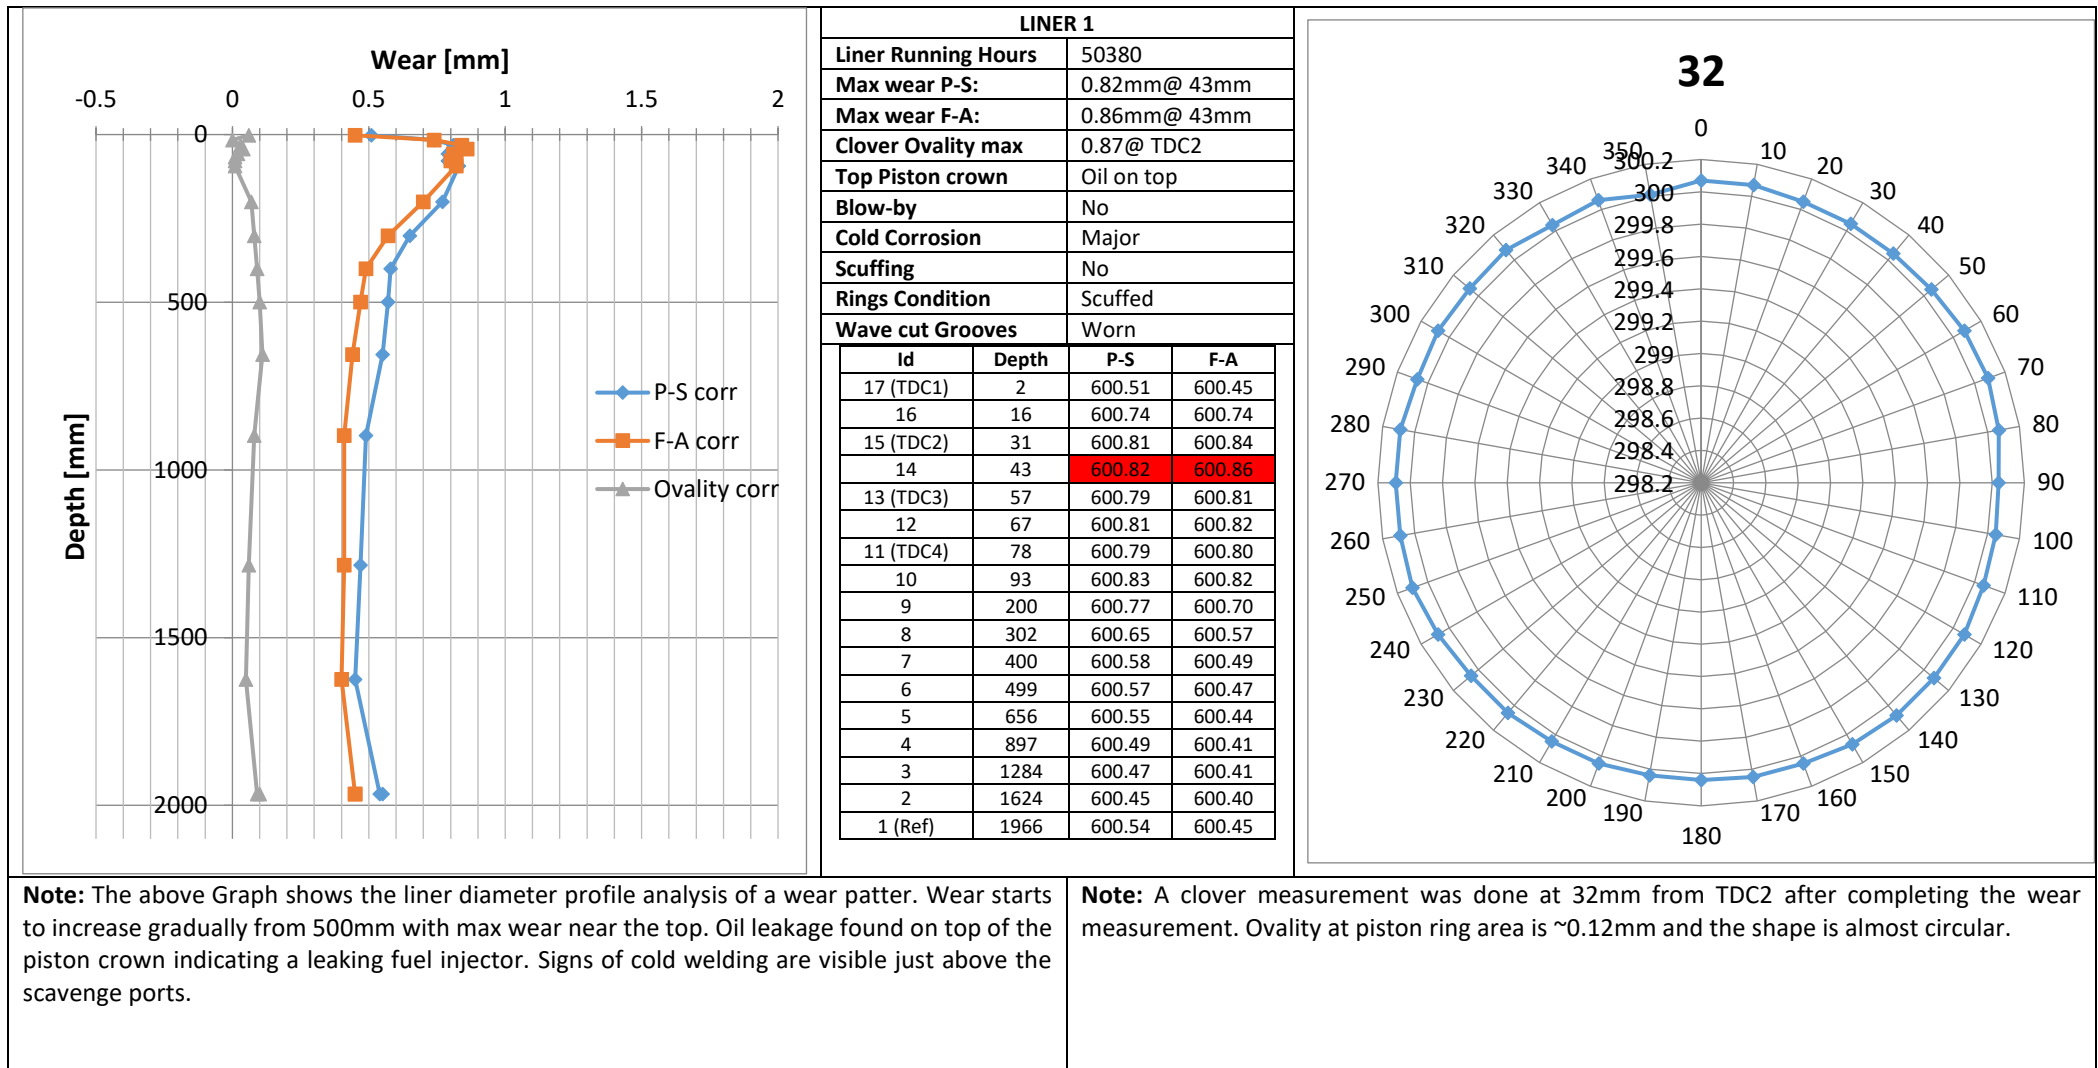
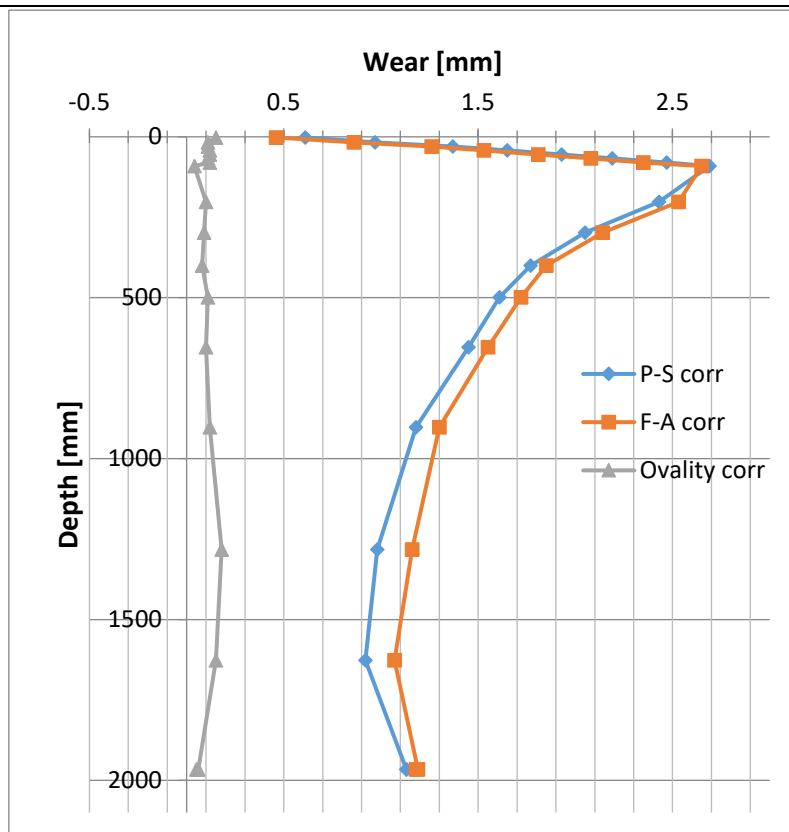
Note: The above Graph shows the liner diameter profile analysis of a wear pattern. Wear starts to increase gradually from 1600mm with max wear near the top. Oil leakage found on top of the piston crown indicating a leaking fuel injector. Liner is suffering from scuffing Sharp burns were found on scavenge port edges.

- Check units 1-4 Fuel Injectors for correct operation. Found to be leaking on units.
- After overhauling fuel injectors monitor with frequent scavenge inspections for the condition of the liner, rings and sludge deposits to evaluate conditions.

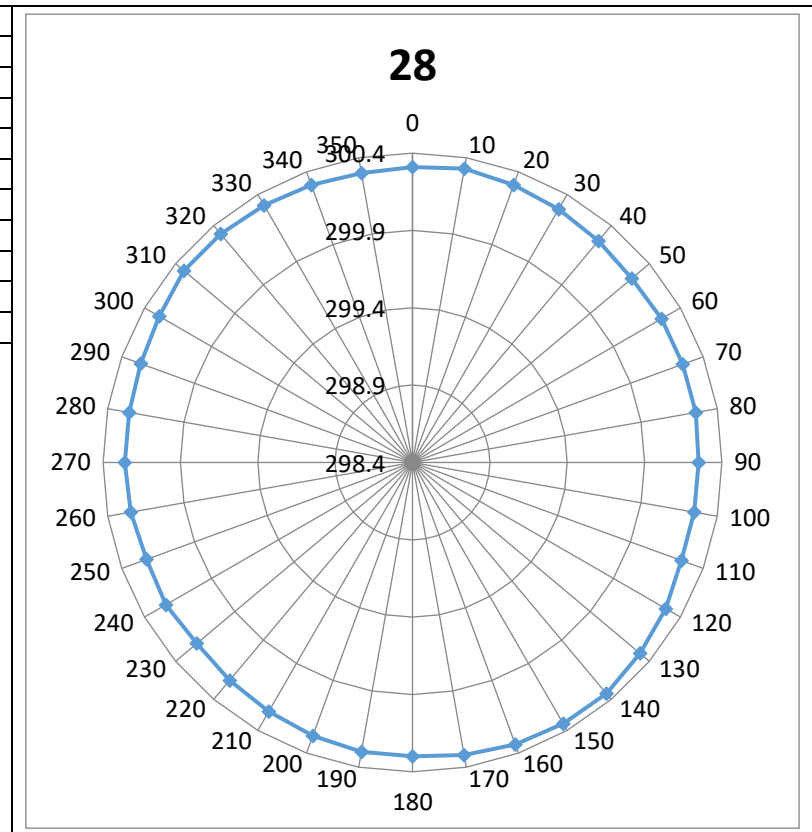
LINER 2			
Liner Running Hours	50380		
Max wear P-S:	2.69mm@ 91mm		
Max wear F-A:	2.65mm@ 91mm		
Clover Ovality max	0.2@ TDC1		
Top Piston crown	Oil on top		
Blow-by	At Ring 1-2-3		
Cold Corrosion	Major		
Scuffing	Yes		
Rings Condition	Scuffed		
Wave cut Grooves	Worn		
Id	Depth	P-S	F-A
17 (TDC1)	2	600.61	600.46
16	17	600.97	600.86
15 (TDC2)	30	601.37	601.26
14	42	601.65	601.53
13 (TDC3)	55	601.93	601.81
12	67	602.19	602.08
11 (TDC4)	80	602.47	602.35
10	91	602.69	602.65
9	202	602.43	602.53
8	298	602.05	602.14
7	400	601.77	601.85
6	499	601.61	601.72
5	654	601.45	601.55
4	903	601.18	601.30
3	1283	600.98	601.16
2	1627	600.92	601.07
1 (Ref)	1966	601.13	601.19

Note: A clover measurement was done at 28mm from TDC1 after completing the wear measurement. Ovality at piston ring area is ~0.20mm and the shape is almost circular. Signs of blow by gas at Ring land 1-2-3 was seen at visual inspection through the scavenge ports. Injectors appear to have poor atomization spray pattern with result spreading fuel on liner wall and then transferred to piston rings affecting the oil film distribution and the build-up of sludge.

Unit 2 appeared with major oily sludge/deposits on the piston ring land which indicates that fuel injectors may not operate as designed with poor atomization of fuel with result spreading fuel on liner wall and then transferred to piston rings affecting the oil film distribution and the build-up of sludge.

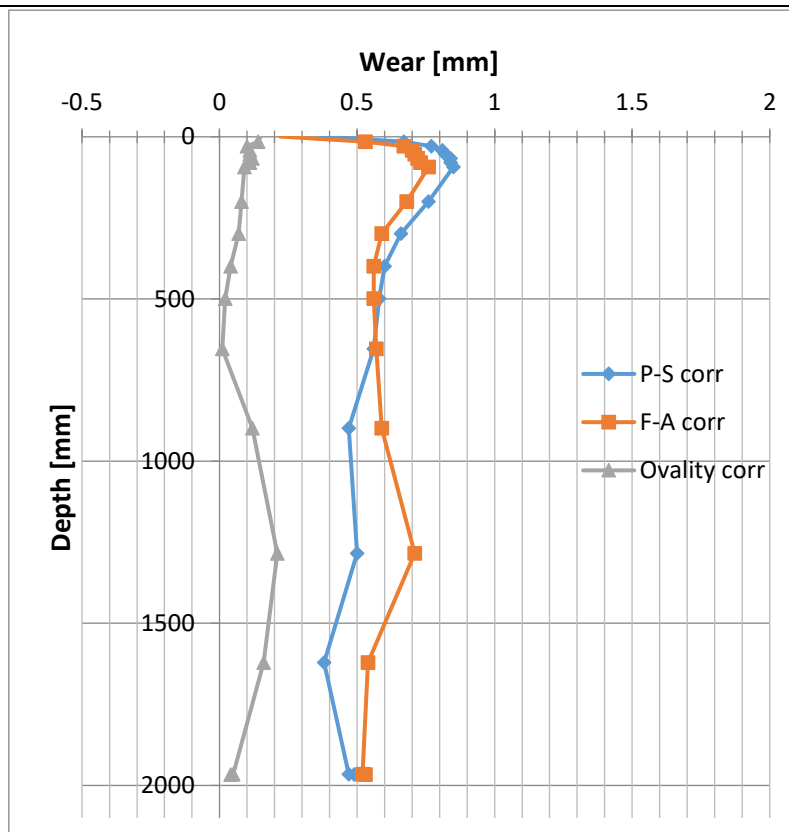
LINER 3				
Liner Running Hours		50380		
Max wear P-S:		0.85mm@ 93mm		
Max wear F-A:		0.76mm@ 93mm		
Clover Ovality max		0.17@ TDC1		
Top Piston crown		Oil on top		
Blow-by		No		
Cold Corrosion		Minor		
Scuffing		Yes		
Rings Condition		Scuffed		
Wave cut Grooves		Worn		
Id	Depth	P-S	F-A	
17 (TDC1)	-1	600.37	600.22	
16	15	600.67	600.53	
15 (TDC2)	29	600.77	600.67	
14	42	600.81	600.70	
13 (TDC3)	54	600.82	600.71	
12	66	600.84	600.72	
11 (TDC4)	79	600.84	600.73	
10	93	600.85	600.76	
9	200	600.76	600.68	
8	298	600.66	600.59	
7	399	600.60	600.56	
6	499	600.58	600.56	
5	654	600.56	600.57	
4	899	600.47	600.59	
3	1284	600.50	600.71	
2	1621	600.38	600.54	
1 (Ref)	1965	600.47	600.52

Note: The above Graph shows the liner diameter profile analysis of a wear pattern. Wear starts to increase gradually from 600mm with max wear near the top. Oil leakage found on top of the piston crown indicating a leaking fuel injector. Liner is suffering from scuffing Sharp burns were found on scavenge port edges. Furthermore, minor signs of black lacquer were visible through the scavenge ports. The result of high humidity in the scavenging air, impacting the cylinder oil, producing alkaline material, forming a patch of deposits. Harmless to the engine and will be worn away when the air becomes dryer.

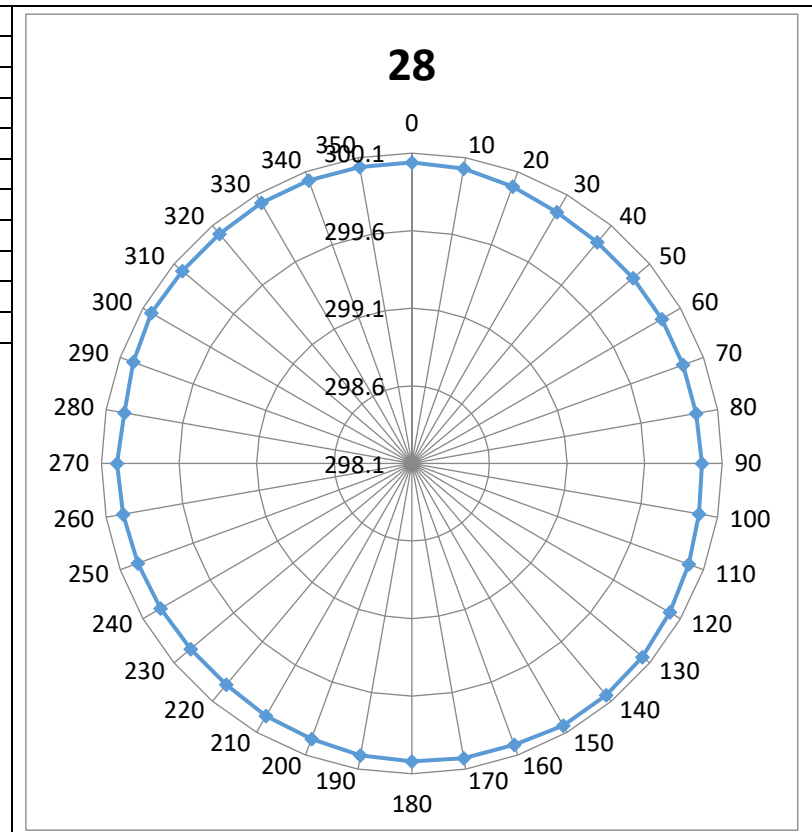
Note: A clover measurement was done at 28mm from TDC1 after completing the wear measurement. Ovality at piston ring area is ~0.17mm and the shape is almost circular.

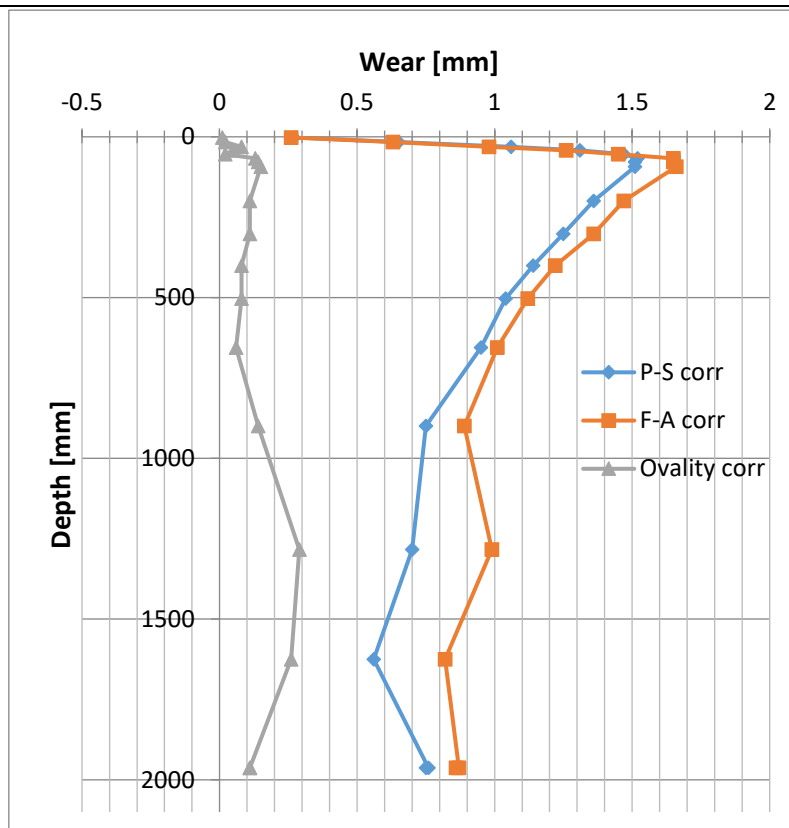
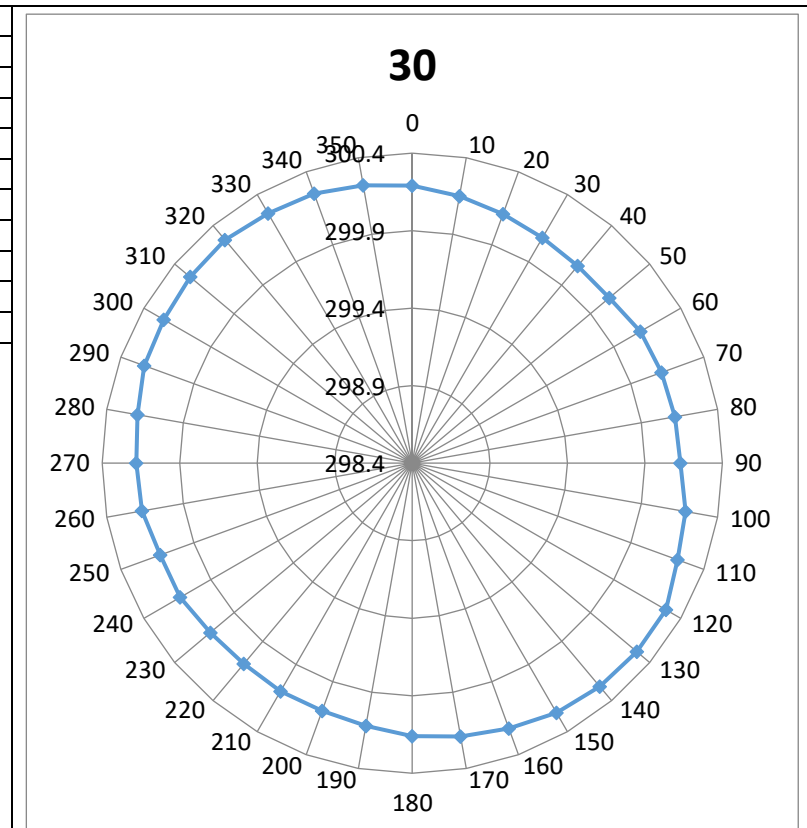
LINER 4			
Liner Running Hours	50380		
Max wear P-S:	1.52mm@ 67mm		
Max wear F-A:	1.66mm@ 93mm		
Clover Ovality max	0.41@ TDC2		
Top Piston crown	Oil on top and rust		
Blow-by	No		
Cold Corrosion	Major		
Scuffing	Yes		
Rings Condition	Scuffed		
Wave cut Grooves	Worn		
Id	Depth	P-S	F-A
17 (TDC1)	2	600.27	600.26
16	16	600.65	600.63
15 (TDC2)	31	601.06	600.98
14	42	601.31	601.26
13 (TDC3)	54	601.47	601.45
12	67	601.52	601.65
11 (TDC4)	78	601.51	601.65
10	93	601.51	601.66
9	199	601.36	601.47
8	302	601.25	601.36
7	401	601.14	601.22
6	503	601.04	601.12
5	655	600.95	601.01
4	899	600.75	600.89
3	1284	600.70	600.99
2	1625	600.56	600.82
1 (Ref)	1963	600.76	600.87

Note: The above Graph shows the liner diameter profile analysis of a wear pattern. Wear starts to increase gradually from 900mm with max wear near the top. Oil leakage found on top of the piston crown indicating a leaking fuel injector. Liner is suffering from scuffing Sharp burns were found on scavenge port edges. Scoring marks were visible on visual inspection, deriving from oil film break down, must be treated with increasing oil feed rate to make rings run again. May otherwise evolve into major scuffing. Trace of water were visible on top piston crown, urgently need to check for water leakage.

Note: A clover measurement was done at 30mm from TDC2 after completing the wear measurement. Ovality at piston ring area is ~0.41mm and the shape is more oval at P-S (320°-130°).

Trace of water was found on Unit 4.

- Check source of water leak needs to be found and rectified.
- Consider honing to refresh the liner surfaces on all units in order to prolong liner life.

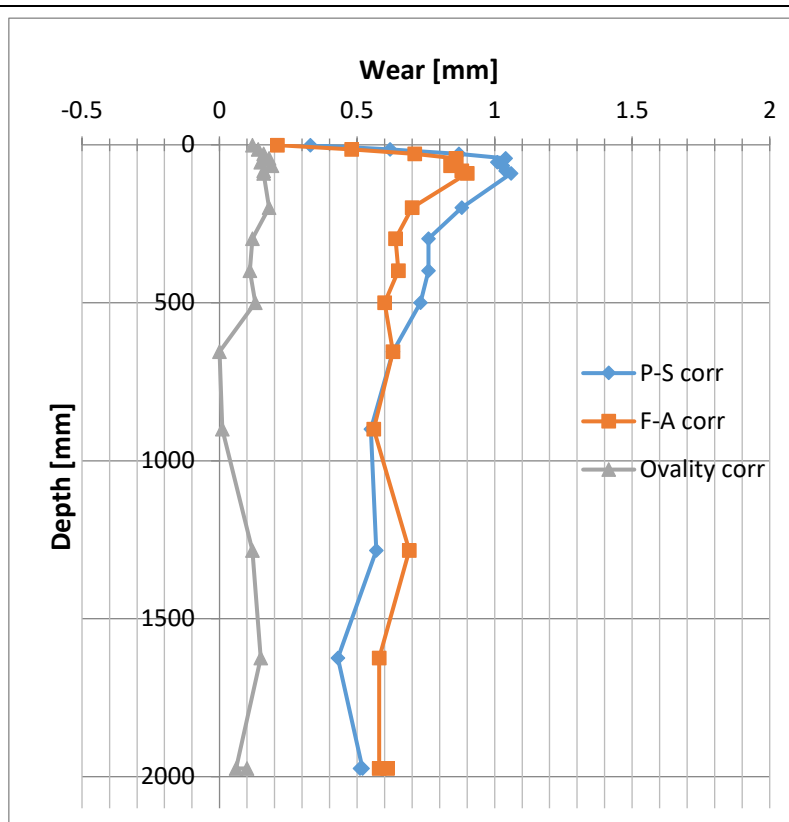
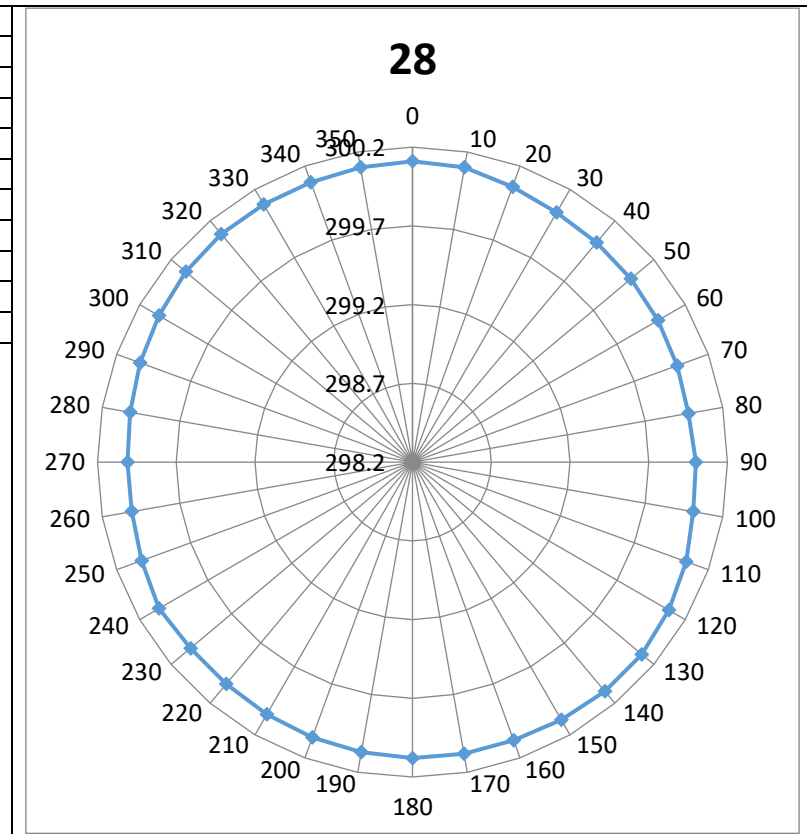
LINER 5			
Liner Running Hours	50380		
Max wear P-S:	1.06mm@ 91mm		
Max wear F-A:	0.90mm@ 91mm		
Clover Ovality max	0.20@ TDC2		
Top Piston crown	Trace of oil		
Blow-by	No		
Cold Corrosion	Yes		
Scuffing	Minor		
Rings Condition	Normal		
Wave cut Grooves	Worn		
Id	Depth	P-S	F-A
17 (TDC1)	1	600.33	600.21
16	15	600.62	600.48
15 (TDC2)	29	600.87	600.71
14	43	601.04	600.86
13 (TDC3)	55	601.01	600.86
12	66	601.03	600.84
11 (TDC4)	82	601.04	600.88
10	91	601.06	600.90
9	199	600.88	600.70
8	297	600.76	600.64
7	399	600.76	600.65
6	500	600.73	600.60
5	655	600.63	600.63
4	900	600.55	600.56
3	1284	600.57	600.69
2	1625	600.43	600.58
1 (Ref)	1974	600.52	600.58

Note: The above Graph shows the liner diameter profile analysis of a wear patten. Wear starts to increase gradually from 600mm with max wear near the top. Liner is suffering from minor scuffing Sharp burns were found on scavenge port edges. Furthermore, minor signs of black lacquer were visible through the scavenge ports. The result of high humidity in the scavenging air, impacting the cylinder oil, producing alkaline material, forming a patch of deposits. Harmless to the engine and will be worn away when the air becomes dryer.

Note: A clover measurement was done at 28mm from TDC1 after completing the wear measurement. Ovality at piston ring area is ~0.20mm and the shape is almost circular.

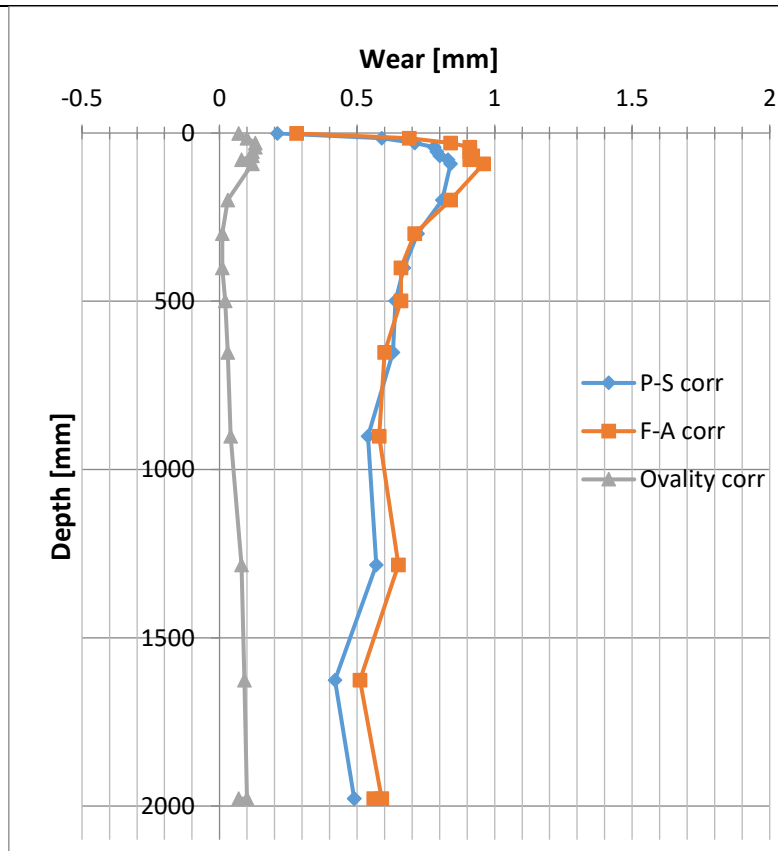
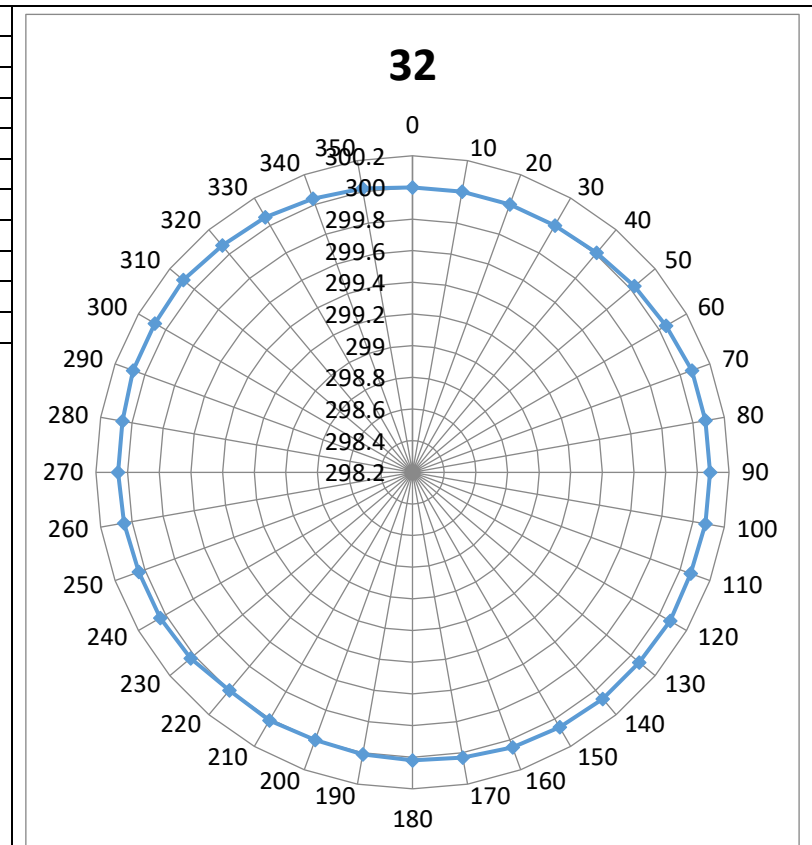
Note: The above Graph shows the liner diameter profile analysis of a wear patter. Wear starts to increase gradually from 600mm with max wear near the top.

LINER 6				
Liner Running Hours		50380		
Max wear P-S:		0.84mm@ 91mm		
Max wear F-A:		0.96mm@ 91mm		
Clover Ovality max		0.16@ TDC2		
Top Piston crown		Trace of oil		
Blow-by		No		
Cold Corrosion		Yes		
Scuffing		No		
Rings Condition		Scuffed		
Wave cut Grooves		Worn		
Id	Depth	P-S	F-A	
17 (TDC1)	1	600.21	600.28	
16	15	600.59	600.69	
15 (TDC2)	30	600.71	600.84	
14	42	600.78	600.91	
13 (TDC3)	55	600.79	600.91	
12	68	600.80	600.92	
11 (TDC4)	79	600.83	600.91	
10	91	600.84	600.96	
9	199	600.81	600.84	
8	299	600.72	600.71	
7	401	600.67	600.66	
6	499	600.64	600.66	
5	652	600.63	600.60	
4	901	600.54	600.58	
3	1283	600.57	600.65	
2	1626	600.42	600.51	
1 (Ref)	1978	600.49	600.59

Note: A clover measurement was done at 32mm from TDC2. Ovality at piston ring area is ~0.16mm and the shape is almost circular.
