LINER DIAMETER MEASUREMENT SERVICE REPORT

General Data

Vessel:	-
Owner/manager:	-
Flag:	-
Engine type:	6S60MC-C
IMO:	-
Running hours:	50380
Built:	2010
Device used:	LDM Generation 4
Stroke:	2292

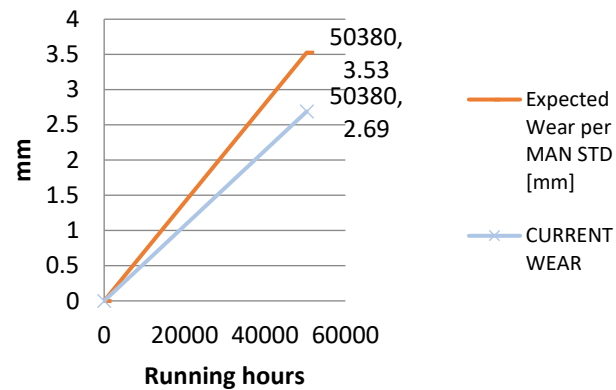
**Measured Wear Vs Man
Std wear Liner 2**

LINER 2			
Liner Running Hours	50380		
Max wear P-S:	2.69mm@ 91mm		
Max wear F-A:	2.65mm@ 91mm		
Clover Ovality max	0.2@ TDC1		
Top Piston crown	Oil on top		
Blow-by	At Ring 1-2-3		
Cold Corrosion	Major		
Scuffing	Yes		
Rings Condition	Scuffed		
Wave cut Grooves	Worn		
Id	Depth	P-S	F-A
17 (TDC1)	2	600.61	600.46
16	17	600.97	600.86
15 (TDC2)	30	601.37	601.26
14	42	601.65	601.53
13 (TDC3)	55	601.93	601.81
12	67	602.19	602.08
11 (TDC4)	80	602.47	602.35
10	91	602.69	602.65
9	202	602.43	602.53
8	298	602.05	602.14
7	400	601.77	601.85
6	499	601.61	601.72
5	654	601.45	601.55
4	903	601.18	601.30
3	1283	600.98	601.16
2	1627	600.92	601.07
1 (Ref)	1966	601.13	601.19

Note: A clover measurement was done at 28mm from TDC1 after completing the wear measurement. Ovality at piston ring area is ~0.20mm and the shape is almost circular. Signs of blow by gas at Ring land 1-2-3 was seen at visual inspection through the scavenge ports. Injectors appear to have poor atomization spray pattern with result spreading fuel on liner wall and then transferred to piston rings affecting the oil film distribution and the build-up of sludge.

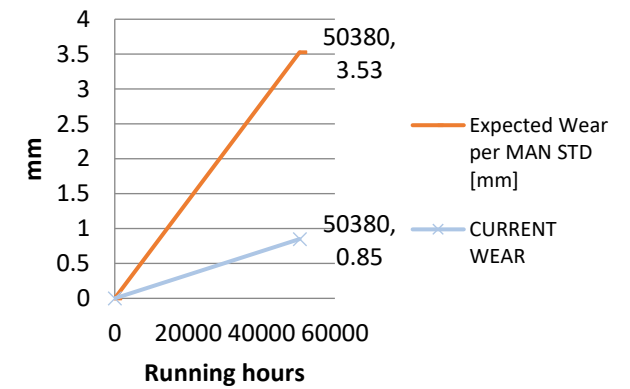
**Measured Wear Vs Man
Std wear Liner 3**

LINER 3				
Liner Running Hours		50380		
Max wear P-S:		0.85mm@ 93mm		
Max wear F-A:		0.76mm@ 93mm		
Clover Ovality max		0.17@ TDC1		
Top Piston crown		Oil on top		
Blow-by		No		
Cold Corrosion		Minor		
Scuffing		Yes		
Rings Condition		Scuffed		
Wave cut Grooves		Worn		
Id	Depth	P-S	F-A	
17 (TDC1)	-1	600.37	600.22	
16	15	600.67	600.53	
15 (TDC2)	29	600.77	600.67	
14	42	600.81	600.70	
13 (TDC3)	54	600.82	600.71	
12	66	600.84	600.72	
11 (TDC4)	79	600.84	600.73	
10	93	600.85	600.76	
9	200	600.76	600.68	
8	298	600.66	600.59	
7	399	600.60	600.56	
6	499	600.58	600.56	
5	654	600.56	600.57	
4	899	600.47	600.59	
3	1284	600.50	600.71	
2	1621	600.38	600.54	
1 (Ref)	1965	600.47	600.52

Note: The above Graph shows the liner diameter profile analysis of a wear pattern. Wear starts to increase gradually from 600mm with max wear near the top. Oil leakage found on top of the piston crown indicating a leaking fuel injector. Liner is suffering from scuffing Sharp burns were found on scavenge port edges. Furthermore, minor signs of black lacquer were visible through the scavenge ports. The result of high humidity in the scavenging air, impacting the cylinder oil, producing alkaline material, forming a patch of deposits. Harmless to the engine and will be worn away when the air becomes dryer.

Note: A clover measurement was done at 28mm from TDC1 after completing the wear measurement. Ovality at piston ring area is ~0.17mm and the shape is almost circular.
